**Supplemental SCDHS Phase II
Environmental Site Assessment**

Indian Hills Country Club

Fort Salonga, New York

December 30, 2016

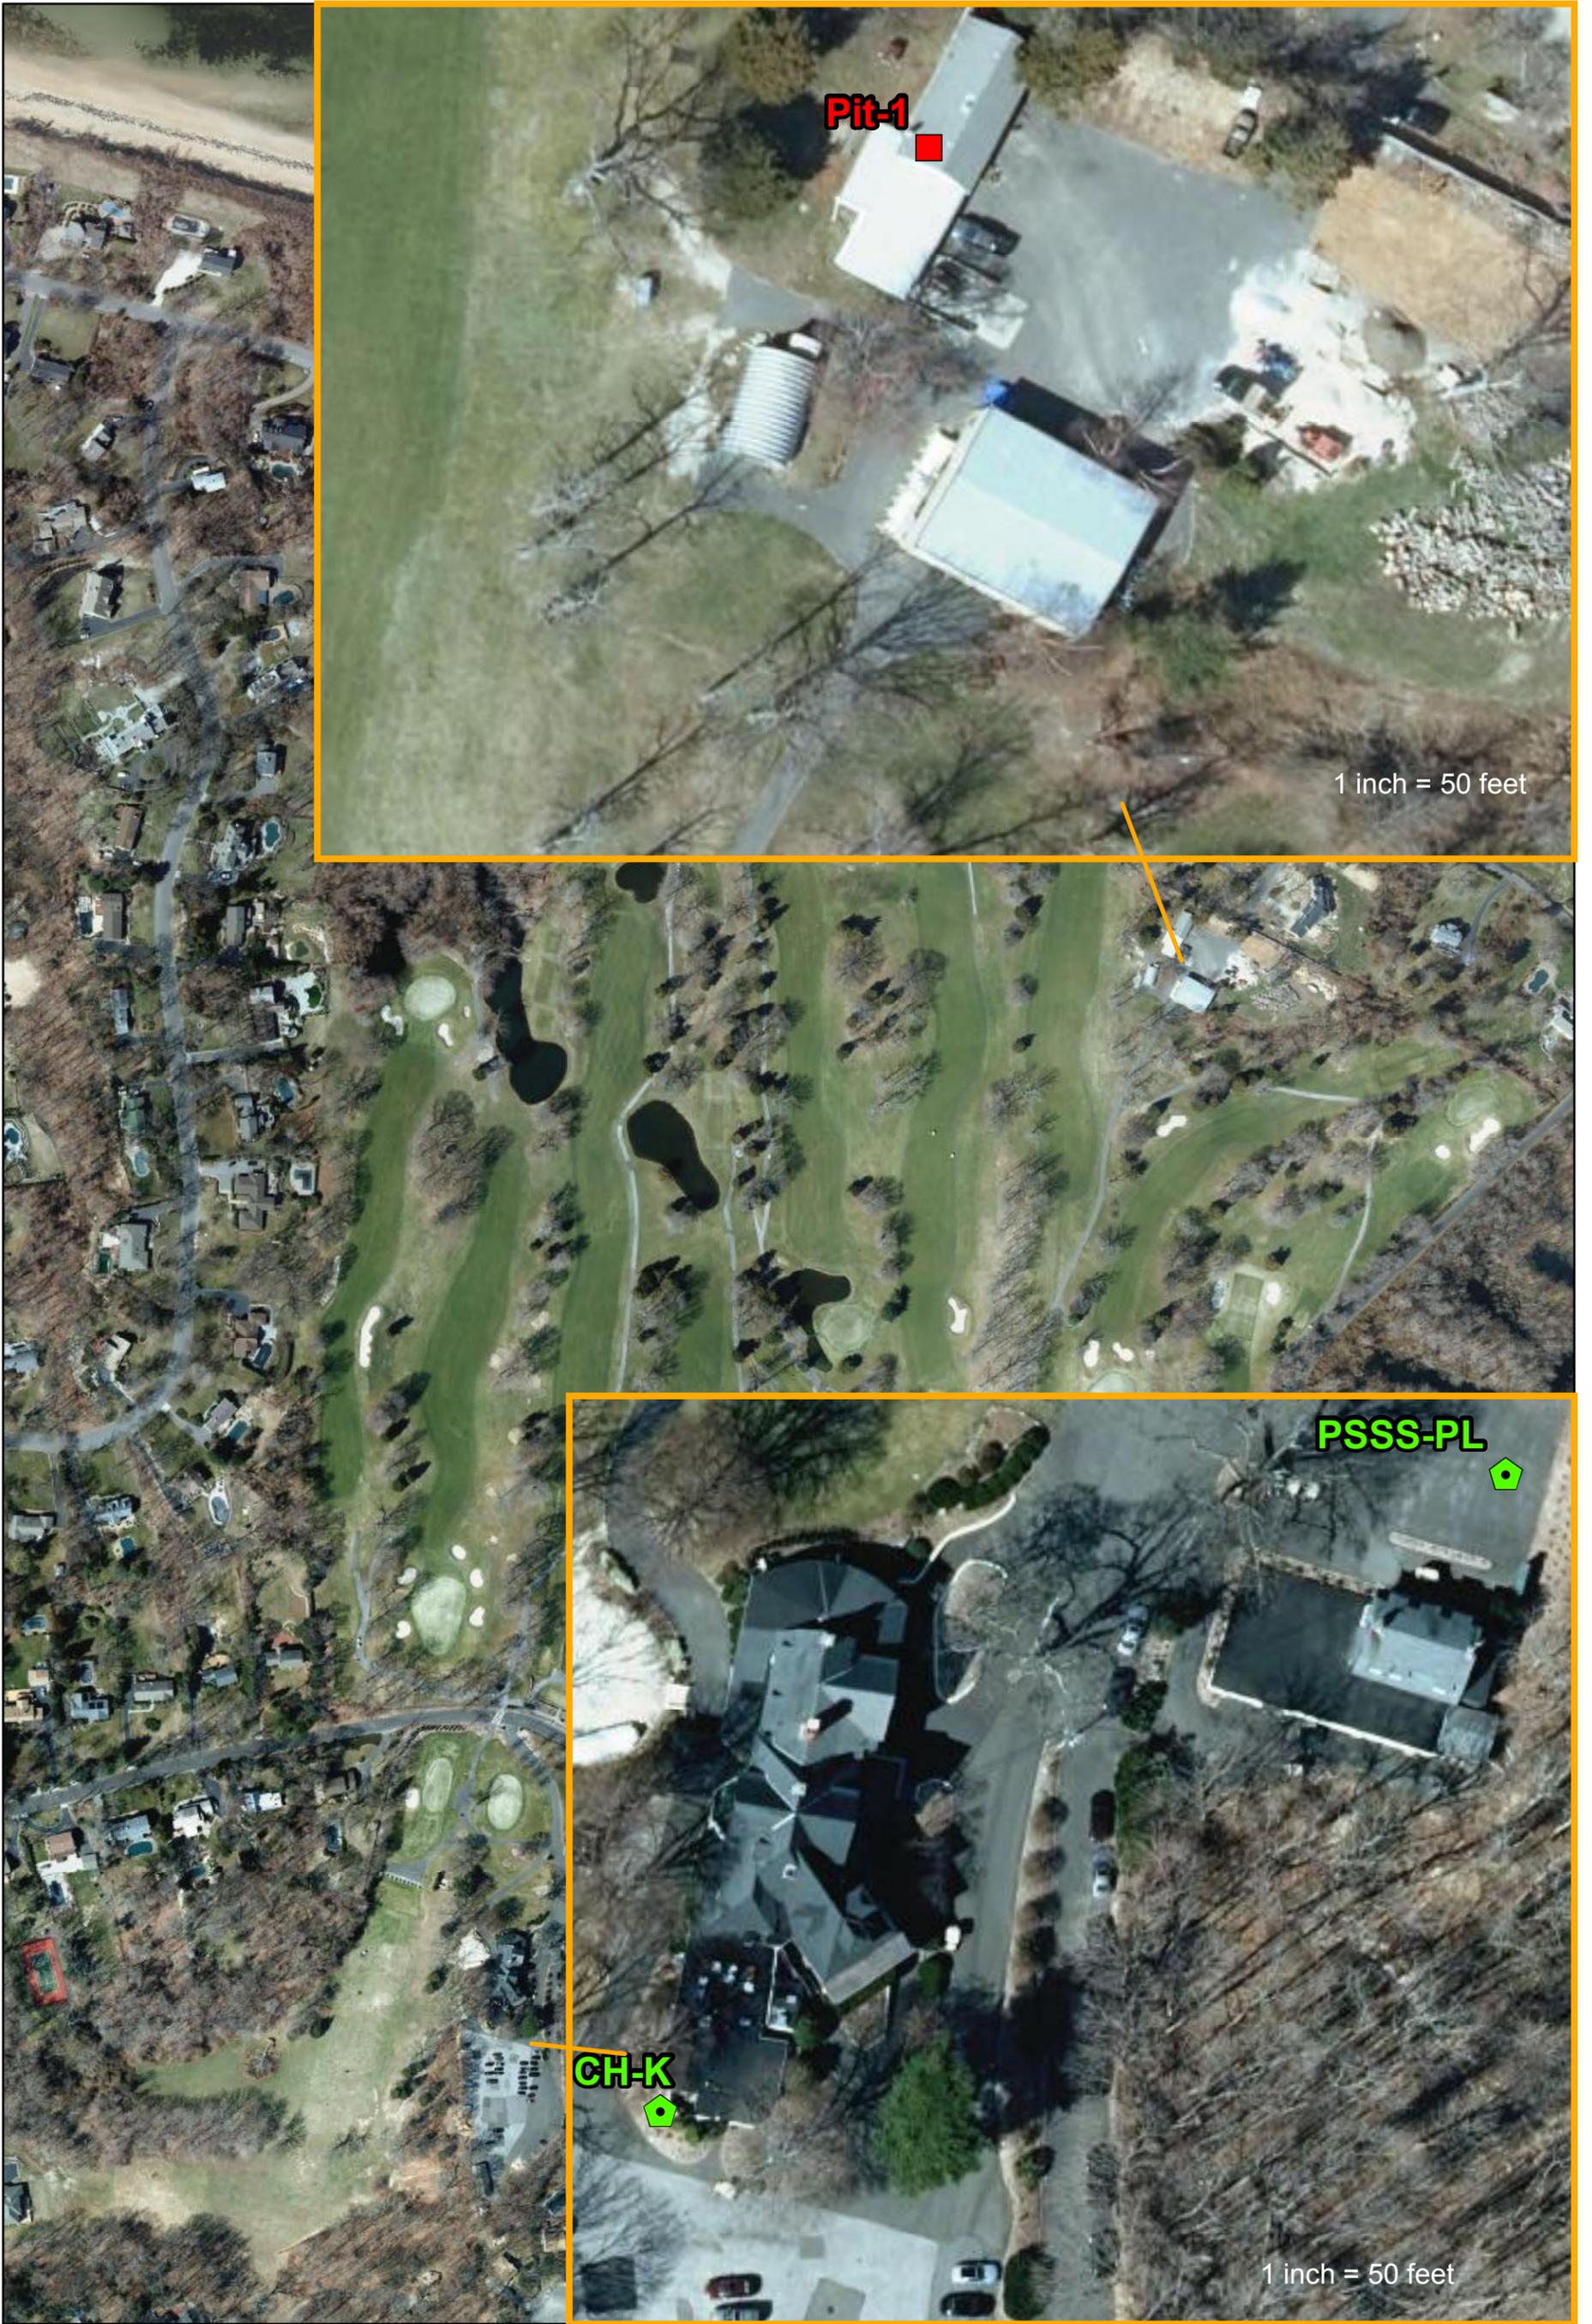
FIGURE 1
SAMPLE LOCATION MAP

The small drywell located on the south side of the main clubhouse building and the Pro Shop on-site sanitary system were sampled using a stainless steel hand auger. A soil sample was collected from the bottom sediment/soils of the drywell. No sample was collected from the Pro Shop septic tank but, one (1) sample was collected from the overflow leaching pool connected to the septic tank. The samples from the drywell and leaching pool were collected from the top zero to twelve (0-12) inches of the soil. The samples were analyzed for the presence of volatile and semi-volatile organic compounds and metals based on the SCDHS parameters. **Figure 1** located at the end of this document provides a location map of the samples collected.

One (1) soil probe was installed within the former maintenance pit located in the maintenance building. **Figure 1** provides a map identifying the location of the above referenced soil probe. The soil probe was installed using a Power Probe sampling apparatus Model 9100, in order to collect soil samples which provide a representation of the subsurface soil at depths that ranged from zero to four (0-4) feet, four to eight (4-8) feet and eight to twelve (8-12) feet below existing grade. The soil samples were visually inspected and the sample which exhibited the bottom of the pit was sent to a laboratory for analysis.

The laboratory analysis performed on the samples did not exhibit any elevated concentrations of semi-volatile organic compounds and metals. Several of the analyzed volatile organic compounds exhibited elevated concentrations. **Table 2** provides a comparison of those constituents with elevated concentrations and the regulatory guidance values. The laboratory analysis sheets (NYS ASPA) as prepared by Long Island Analytical Laboratories are presented in **Appendix A** of this document. As depicted in **Table 2**, several of the analyzed constituents in samples CH-K exceeded the regulatory guidance values set forth in the SCDHS SOP 9-95. Since these concentrations exceed the SCDHS guidance values, it is recommended that CH-K be remediated under the auspices of SCDHS personnel.
